# *SWF Home Inspections*

## Property Inspection Report

123 Somewhere in, Southwest, FL  
Inspection prepared for: Mr & Mrs Home Buyer  
Real Estate Agent: My Favorite Agent -

Date of Inspection: 7/4/2013  
Age of Home: 2004 Size: 1568  
Weather: Partly Cloudy

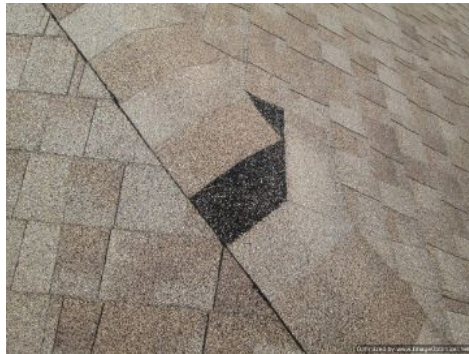
Page 3	Condition	<ul style="list-style-type: none"> <li>• There is or are damaged tab(s) that should be repaired.</li> </ul>
--------	-----------	---

Damaged Shingle

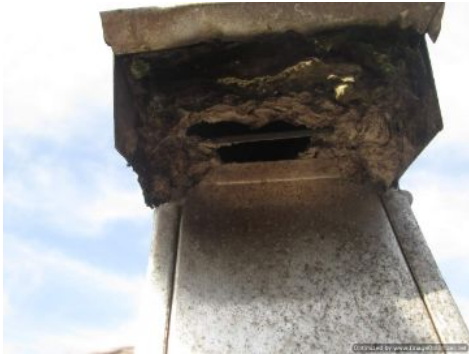
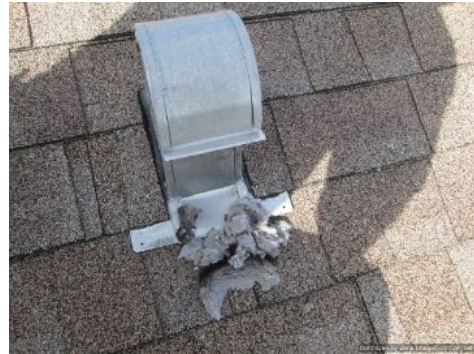
Page 3	Dryer Vent	<ul style="list-style-type: none"> <li>• The exterior dry vent hood is full of lint and needs to be cleaned.</li> </ul>
--------	------------	---

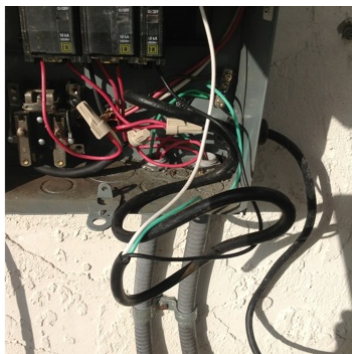
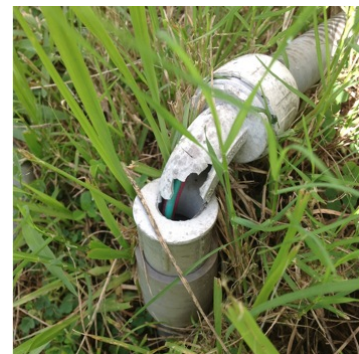
Page 5	Well equipment	<ul style="list-style-type: none"> <li>• The filter has been electrically disconnected.</li> <li>• Conduit covering the wires for the well pump needs to be repaired.</li> </ul>
--------	----------------	--

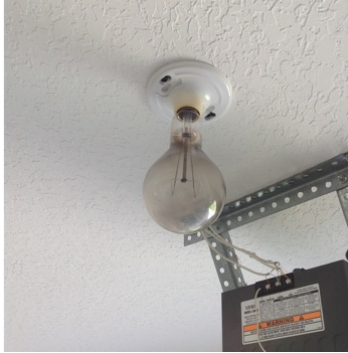
Lights

• The light did not work. It may be just a burnt bulb.

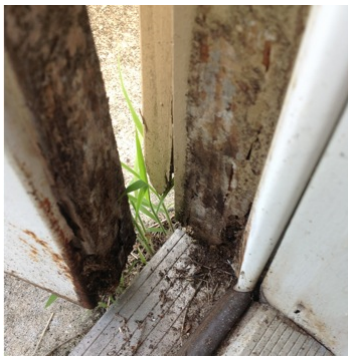
Garage side door

• The base of the garage side door is moisture damaged.

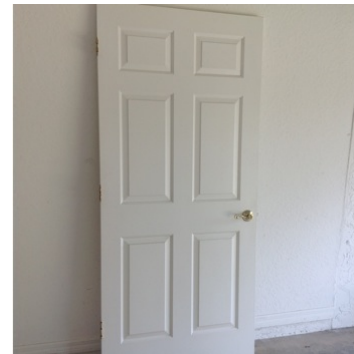
Doors

• The door is missing. It is in the garage.

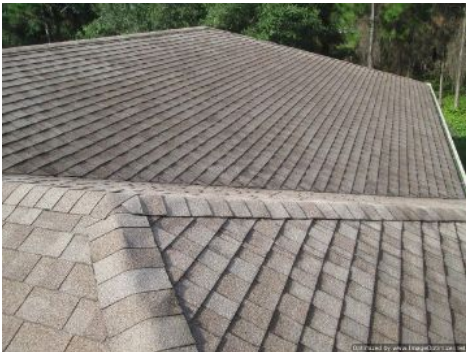
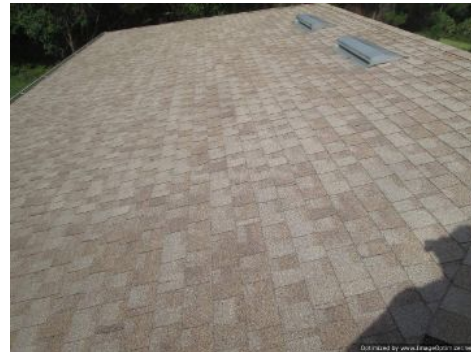
- Asphalt shingles noted.
- The roof is approximately 10 years old.
- We evaluated the roof and its components by walking on its surface.
- The roof flashings are in acceptable condition.
- The fascia board and soffit are in acceptable condition.
- The gutters are in acceptable condition at the time of the inspection.
- The dryer vent on the roof should be cleaned every 6 to 9 months depending on usage.
- The lead boots are acceptable at the time of the inspection.

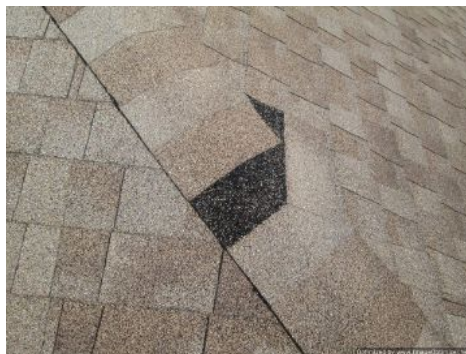
- **\*\*ASPHALT SHINGLES\*\***
- There is or are damaged tab(s) that should be repaired.

Damaged Shingle

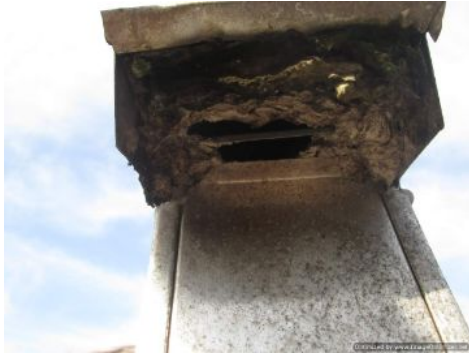
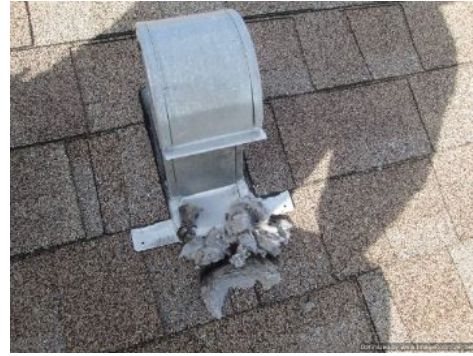
- The exterior dryer vent hood is full of lint and needs to be cleaned.

- Add a back flow preventer to all hose bibbs.
- Clean the dryer vent every 3 to 6 months depending upon usage.
- Add a gutter guard to the gutters to prevent tree debris from clogging up the gutters and causing roof damage.

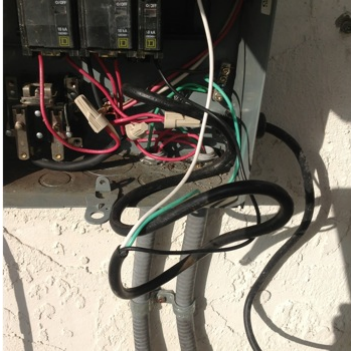
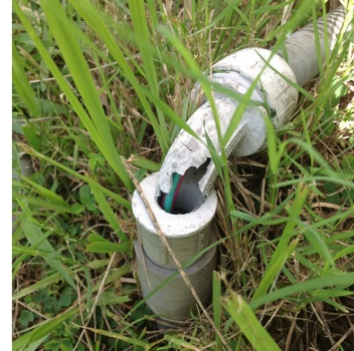
- Potable water supplied by well. Suggest water testing within inspection contingency period.
- The filter has been electrically disconnected.
- Conduit covering the wires for the well pump needs to be repaired.

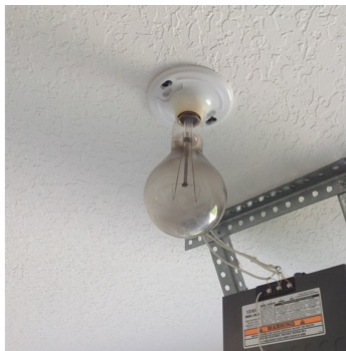
- The light did not work. It may be just a burnt bulb.

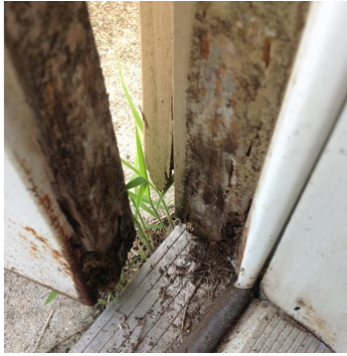
- The base of the garage side door is moisture damaged.

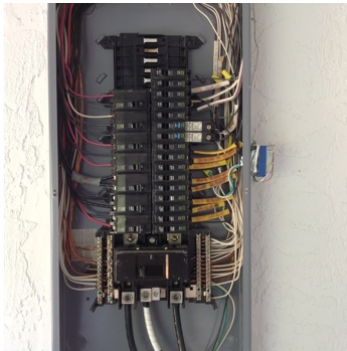
- OVERHEAD
- The service entrance, mast weather head, and cleat are in acceptable condition.
- 200 amp
- The interior main panel is located in the garage.
- The main panel and its components have no visible deficiencies.
- The visible portions of the copper wiring have no visible deficiencies.
- There are no visible deficiencies with the circuit breakers.

- The panel is grounded to a driven rod.

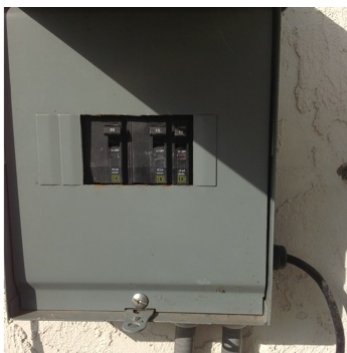
- The sub panel is located by the well equipment.
- The sub panel has no visible deficiencies.

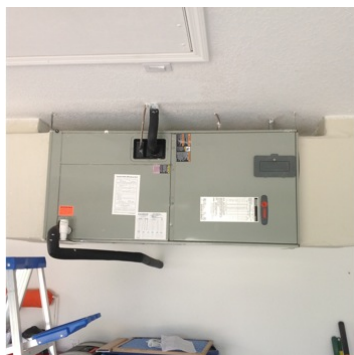
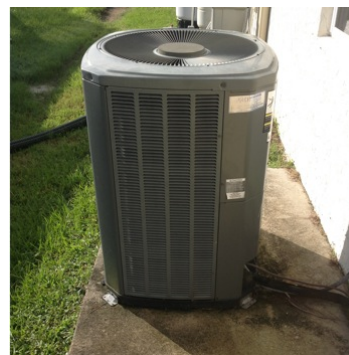
- Central heat and air-conditioning are provided by a heat pump system.
- The air handler is 10 year(s) old and located in the garage.
- The condensing unit is 9 year(s) old and located at the left side of the house.
- The air handler achieved a temperature differential of 14 to 22 degrees. The system was working properly at the time of the inspection.
- The filter is located inside the air handler.
- The filter is located in a filter grill in an interior area ceiling.
- The filter is clean at this time and should be cleaned or changed every month depending on the type of filter.
- The return air supply system appears to be functional.
- The registers are reasonably clean and functional.

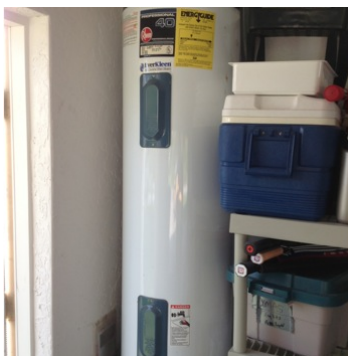
- Hot water is provided by a 9 year old 40 gallon electric water heater located in the garage.
- The electrical connection to the water heater is functional.
- The shut-off valve and water connectors are functional
- The water heater is equipped with a mandated TPR (pressure-temperature relief valve) and discharge pipe.
- The water heater is equipped with a drain pan and discharge pipe, which is designed to prevent water damage from a leak. Nevertheless, the water heater should be periodically monitored for any signs of a leak.

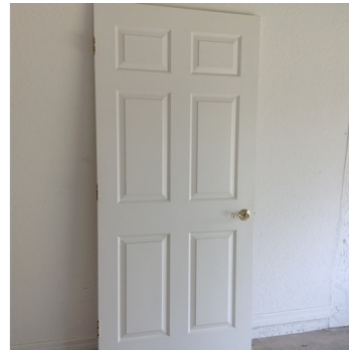
- The door is missing. It is in the garage.

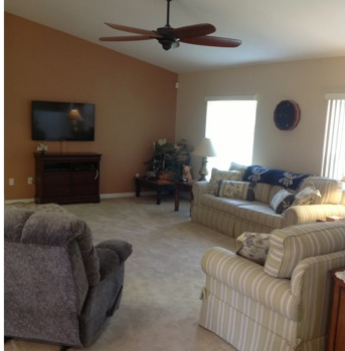
- There are no issues with the floor, walls or ceiling at the time of the inspection.
- The window(s) that were not obstructed were tested and worked properly.
- The smoke detector was tested by pushing the button and it responded. Pushing the "Test" button only verifies that there is power at the detector--either a battery or hard wired to the house power--and not the operational workings of the detector. The operational check is done by filling the sensor with smoke and is beyond the scope of this inspection. Battery operated smoke alarms should be checked routinely and the batteries changed frequently.
- The ceiling fan worked.
- The outlets that were tested worked properly.

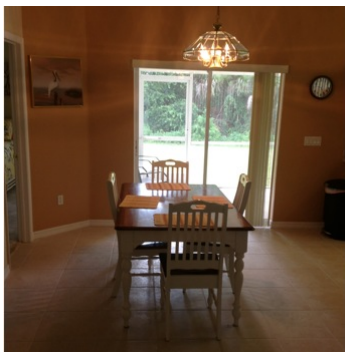
## Dining Room

- The slide door worked properly.
- There are no issues with the floor, walls or ceiling at the time of the inspection.
- The smoke detector was tested by pushing the button and it responded. Pushing the "Test" button only verifies that there is power at the detector--either a battery or hard wired to the house power--and not the operational workings of the detector. The operational check is done by filling the sensor with smoke and is beyond the scope of this inspection. Battery operated smoke alarms should be checked routinely and the batteries changed frequently.
- The lights worked.
- The outlets that were tested worked properly.

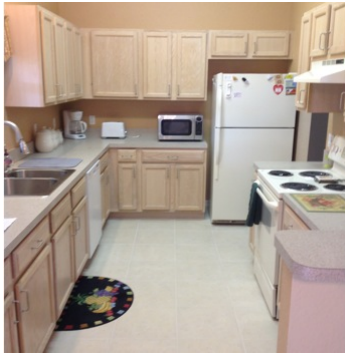
## Kitchen

- All the windows that were not obstructed worked properly.
- There were no issues with the floor, walls and ceiling.
- The lights worked properly.
- The GFCI outlets that were tested worked properly.
- The cabinets worked properly.
- The sink and faucet worked properly.
- The hand sprayer worked properly.
- There were no issues with the shut off valves or trap and drain.
- The garbage disposal worked properly.
- The dishwasher progressed through its normal cycles.
- The exhaust fan and light worked properly.
- The stove worked properly. It was not calibrated as part of out inspection.
- The refrigerator was working properly. It is recommended to keep the temperature between 34 and 42 degrees. If there was an ice maker it was not tested as part of this inspection since it can take up to 24 hours to make a container of ice.

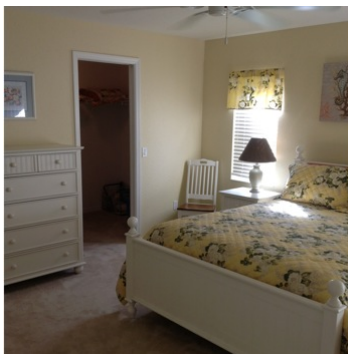
- The bedroom is located at the left rear.
- The door(s) work properly.
- The sliding door was functional during the inspection.
- The windows that were unobstructed were tested and functional.
- There were no issues with the floor, walls and ceiling.
- The closet and all its components are functional.
- The ceiling fan worked properly.
- The smoke detector was tested by pushing the button and it responded. Pushing the "Test" button only verifies that there is power at the detector--either a battery or hard wired to the house power--and not the operational workings of the detector. The operational check is done by filling the sensor with smoke and is beyond the scope of this inspection. Battery operated smoke alarms should be checked routinely and the batteries changed frequently.

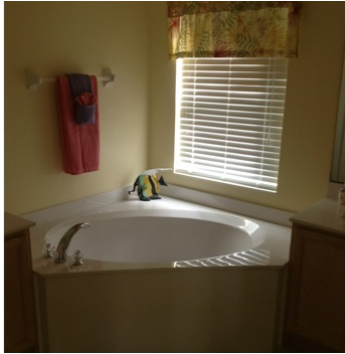
## Master bathroom

- The master bathroom is a full bathroom.
- The door is functional.
- The window was tested and worked properly.
- There are no issues with the floor, walls or ceiling at the time of the inspection.
- The lights worked.
- The GFCI outlets that were tested are functional.
- The bath fan was operated and no issues were found.
- The light on the bath fan works.
- The sink and all its components worked properly.
- The faucet operated normally, at time of inspection.
- The valves and connectors below the sink are functional.
- The trap and drain are functional.
- The tub was functional.
- The stall shower is functional.
- The toilet was observed as functional and in good visual condition.

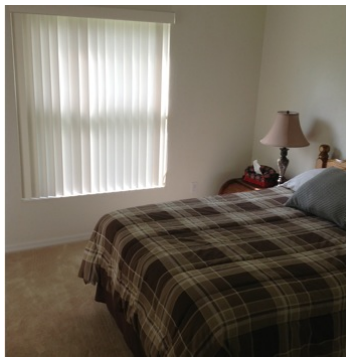
- The bedroom is located at the left rear.
- The door(s) work properly.
- The sliding door was functional during the inspection.
- The windows that were unobstructed were tested and functional.
- The closet and all its components are functional.
- The outlets that were tested are functional.
- The ceiling fan worked properly.
- The smoke detector was tested by pushing the button and it responded. Pushing the "Test" button only verifies that there is power at the detector--either a battery or hard wired to the house power--and not the operational workings of the detector. The operational check is done by filling the sensor with smoke and is beyond the scope of this inspection. Battery operated smoke alarms should be checked routinely and the batteries changed frequently.
